SURVEILLANCE

AND INSPECTION REPORT

Project Name: Davis Vineyard Stage 2

Reference No.: 2372-008

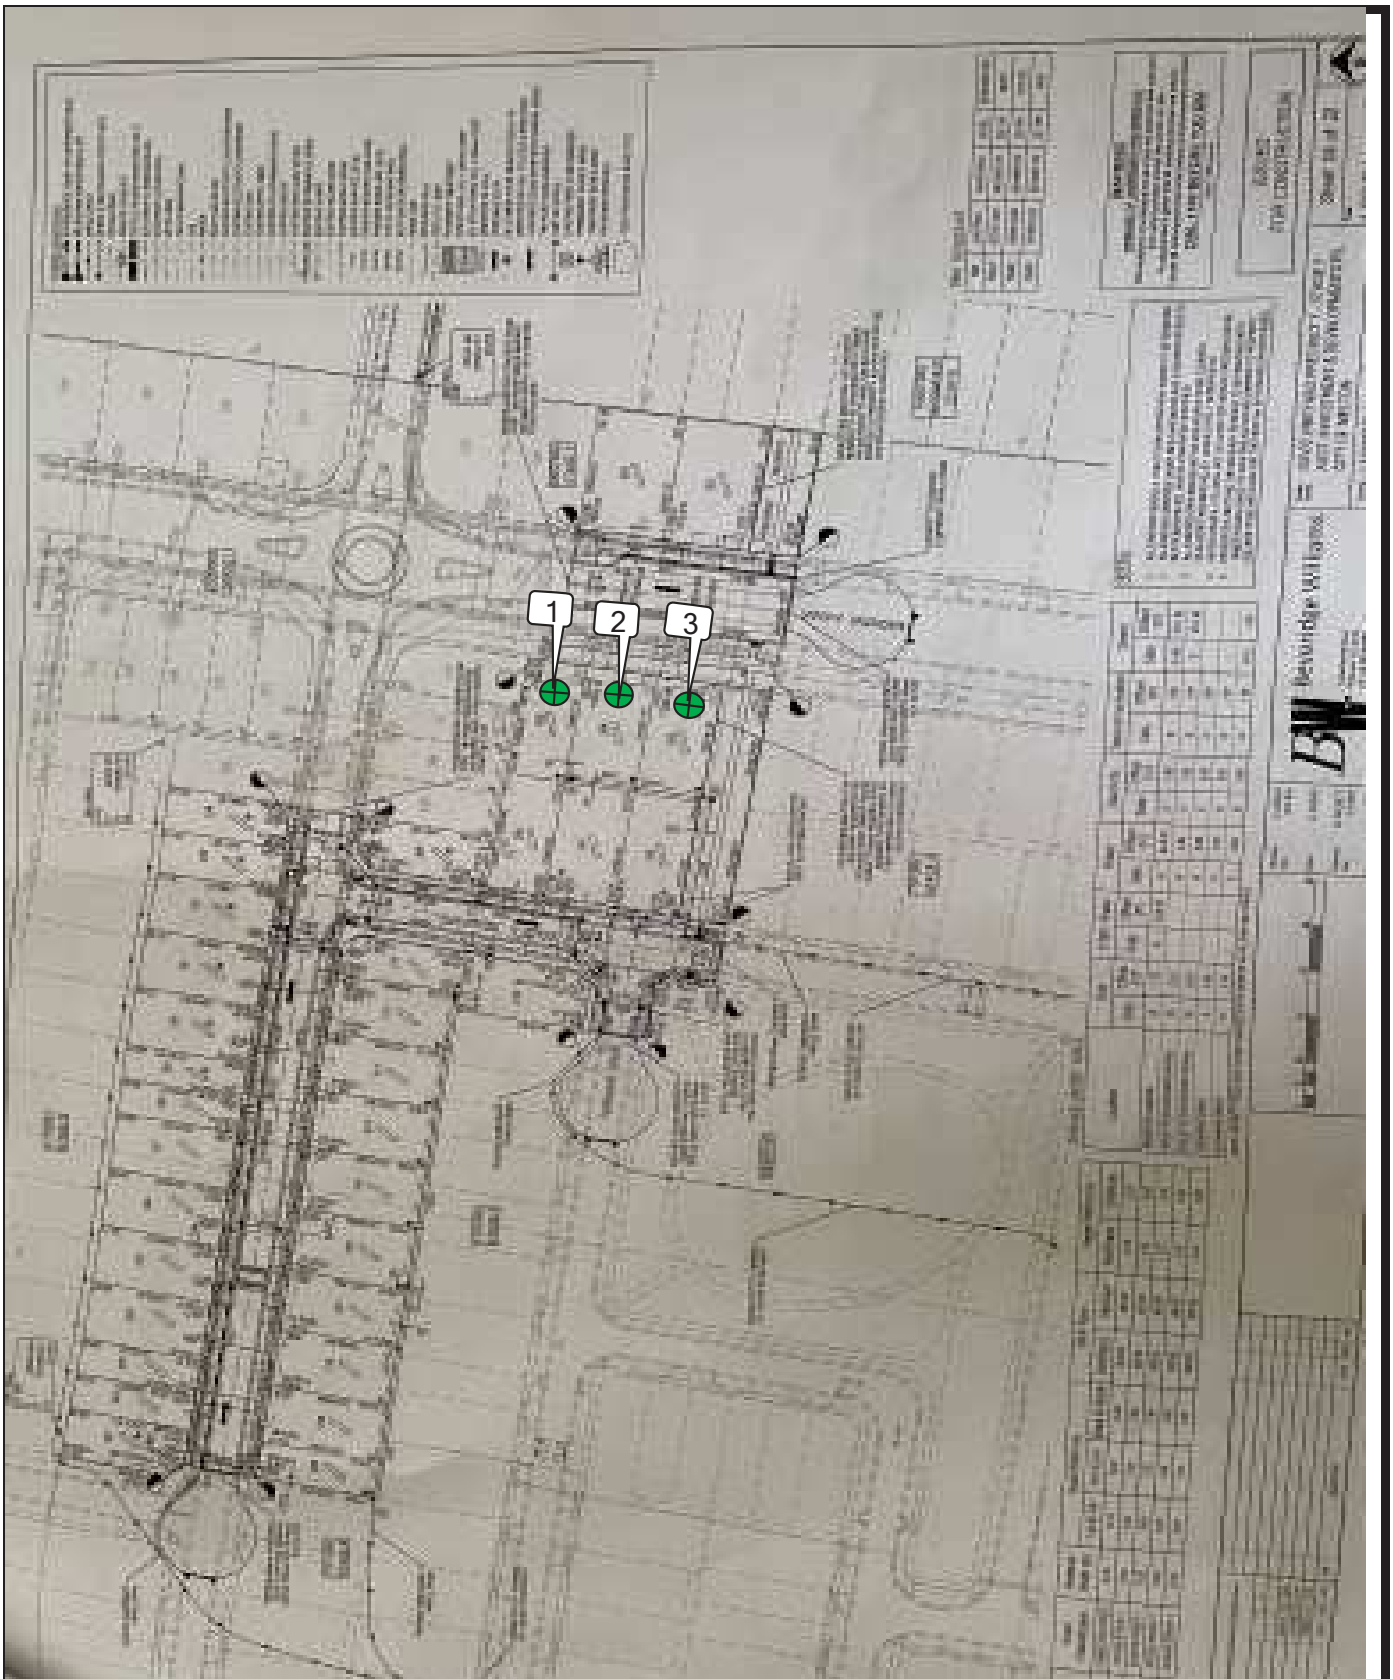
**Sketch indicating compaction test locations**

A total of three compaction tests were performed on the fill construction. Results are presented in Appendix B of this report.

All test results indicate that the above-mentioned requirements have been successfully achieved.
