LEVEL ONE

SURVEILLANCE

AND INSPECTION REPORT

Project Name: Davis Vineyard Stage 4

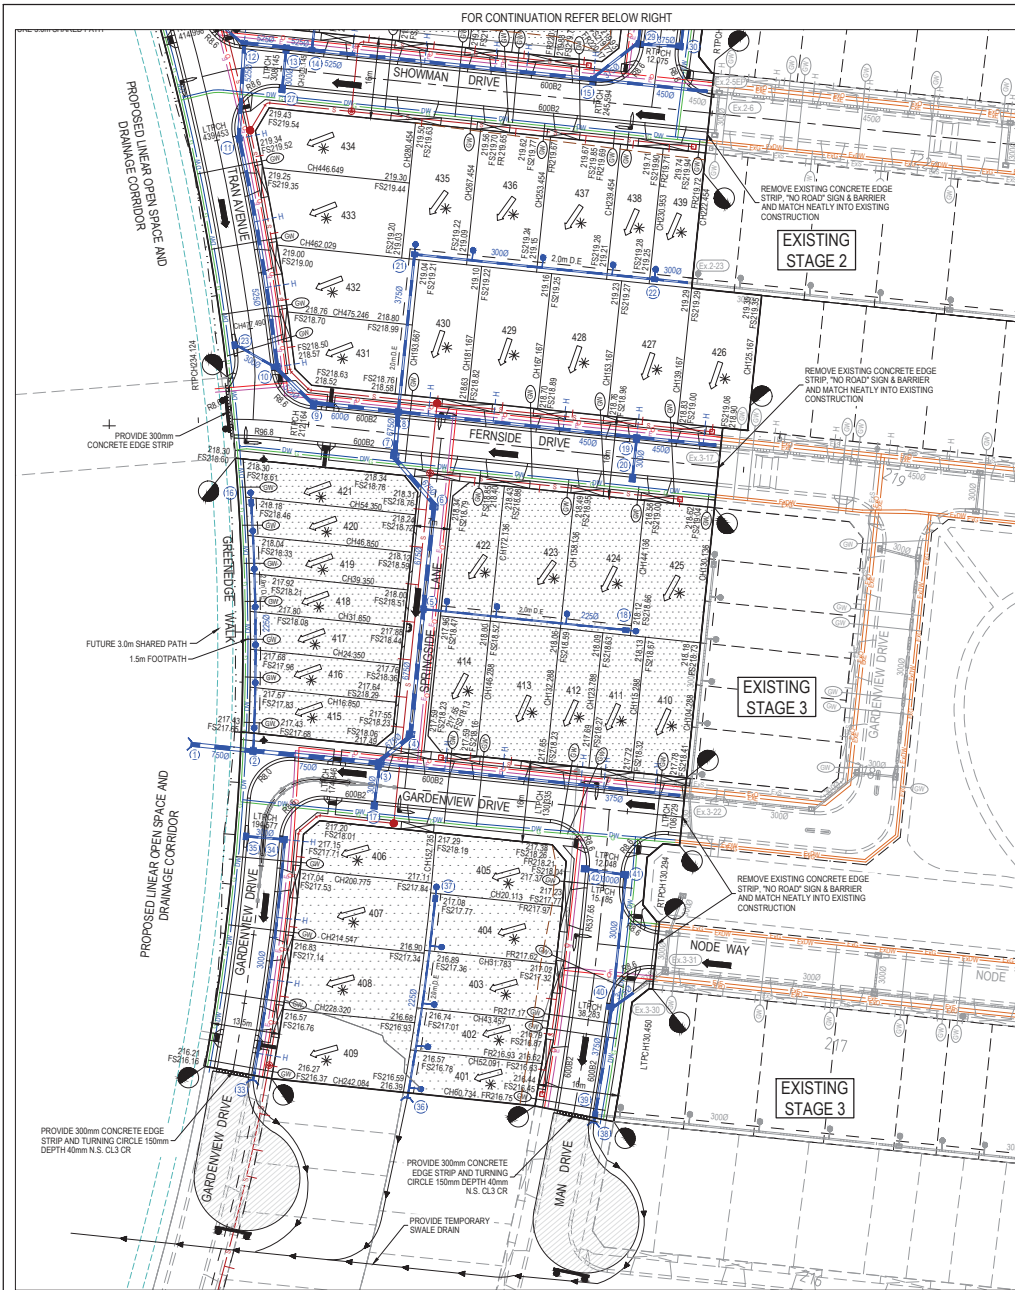
Drawing Title: LAYOUT PLAN (SHEET 1 OF 2)

(1). Site Layout Plan (Sheet 1 of 2) Project Ref. 1600059, Drawing Number 010 (Rev B).
