SURVEILLANCE

### AND INSPECTION REPORT

Client Name: Civilworx Constructions Pty Ltd Project Name: Davis Vineyard Stage 1 Date: 8<sup>th</sup> of November 2021 Author: Mr. Sam Loza Reference No.: 2372-005 Revision: 0 Project Manager: Mr. Brittany Gardiner

### 1. Introduction & Scope

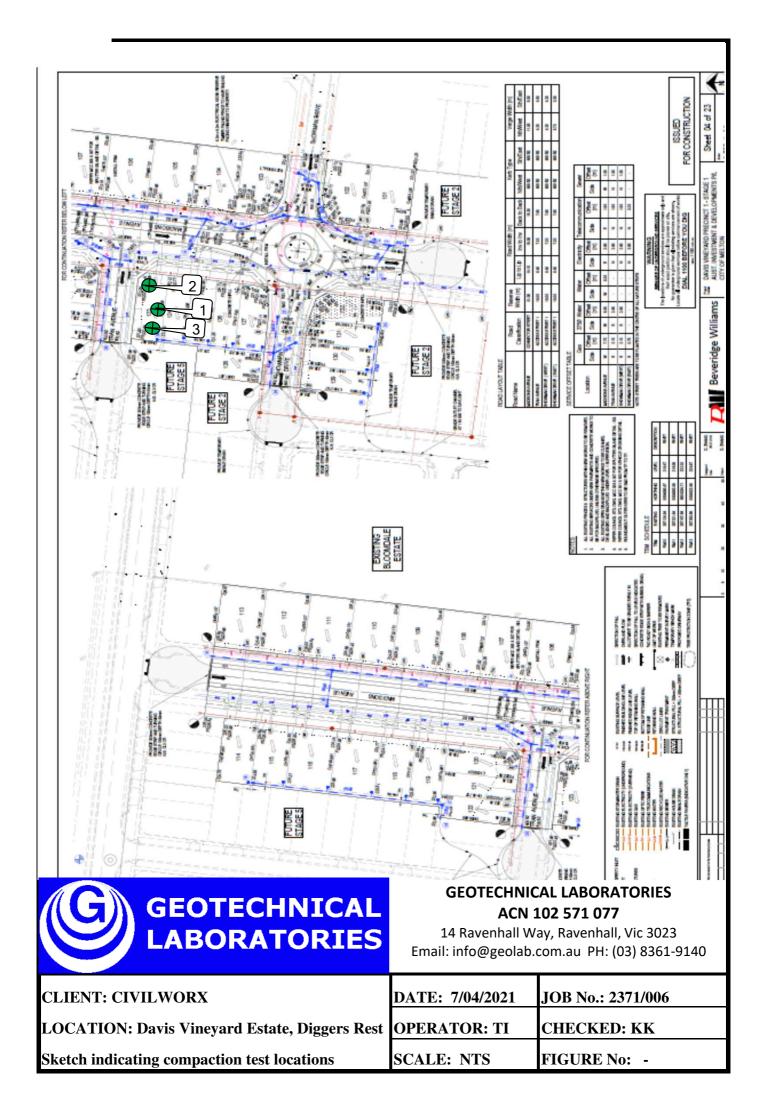
REPORT NO.: # 2371/005

### **DAILY SUMMARY - FIELD DENSITY TESTS**

DATE OF TESTS	TEST NUM.	TEST LOCATION	FIELD WET DENSITY (t/m³)	FIELD MOISTURE CONTENT (%)	HILF DENSITY RATIO STANDARD (%)	STANDARD PCWD OR APCWD (t/m <sup>3</sup> )	STANDARD OPTIMUM MOISTURE CONTENT (%)	PROBE DEPTH SETTING (mm)	VARIATION FROM OPTIMUM MOISTURE CONTENT (%)	MOISTURE RATIO (%)	WET +19mm (%)	WET +37.5mm (%)	APPROX. DEPTH BELOW FINISH LEVEL (mm)
7/04/21	1		1.98	17.0	104.0	1.91	21.0	175	4.5 Drier	79.0	0	0	0
7/04/21	2		1.95	22.0	99.0	1.97	21.0	175	0.5 Wetter	103.5	0	0	300
7/04/21	3	Refer to #2371/006 for approx. test site locations.	1.99	15.5	102.5	1.94	19.5	175	4.5 Drier	77.5	0	0	200

-	-		-	-	-	-	-	-	-	-	-	-	-
-	-		-	-	-	-	-	-	-	-	-	-	-
-	-		-	-	-	-	-	-	-	-	-	-	-
NOTES:       Clayey Fill Ex. Onsite       Compaction specimens sampled after compaction.         Test sites located - Geolab Procedure 4, Part 4.4.       Start Time: 9:55am       Finish Time: 10:25am													
A Hilf Rap	A Hilf Rapid Compaction test was carried out on a sample taken from each Field Density location to obtain the Compaction Parameters tabulated on this Report.												
						Moistu	re Content:	AS 1289	2.1.1			10	
	Soil Layer thickness: 200mm					Compaction Test: AS 1289 5.7.1 MilQ							
Hilf Density Ratio and Hilf Moisture Variation, Hilf Adjusted (APCWD) & Peak (PCWD) Converted Wet Density AS 1289 5.7.1													
Field Den	sity, N	uclear Gauge: AS 1289 5.8.1		Accredited for compliance with ISO/IEC					MICK CROWE				
Materials	Samp	led: AS 1289 1.2.1 Clause 6.4(b	NATA	<u> 17025 - Te</u>	esting				(Approv	ed Signa	atory)
